Urban trees and associated root problems: Part 1

Steve Batchelder and Molly Batchelder

THE FOLLOWING DISCUSSION COVERS SOME of the more common causes of sidewalk, curbing and pavement damage associated with tree roots. A number of possible treatments for existing root/hardscape conflicts are provided as well as some approaches to reduce the potential for problems through improved site preparation.

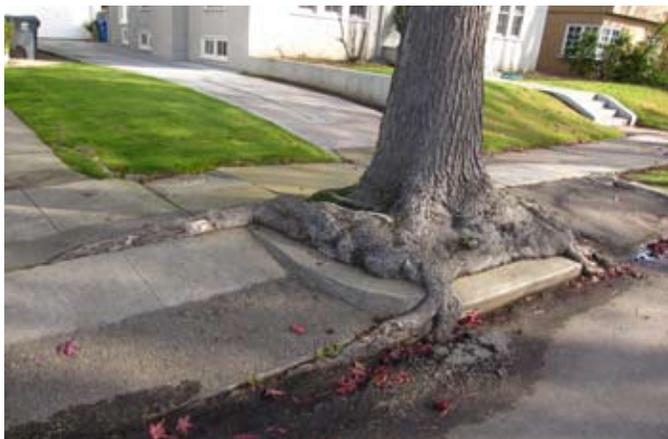
Restrictive site conditions surrounding this *Liquidambar* tree are contributing to the pavement damage. Irrigation water from the lawn nearby drains toward the tree and has encouraged root development under the sidewalk. Sidewalk, driveway apron, curb and gutter, as well as the street pavement have all been impacted. Deciding what can and/or should be done at this point often involves difficult and time-consuming decisions involving city staff, adjacent residents, and city commissions. The city opted to retain the tree because it contributes significantly to canopy cover. If a more prudent decision had been made at the time of planting, long-term maintenance costs would have been greatly reduced.

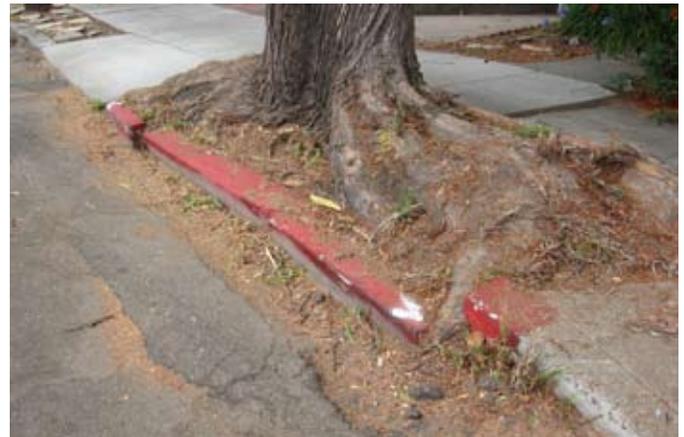
This photo illustrates what can happen when there is a poor match between the size of the tree species at maturity and site constraints. This silk oak (*Grevillea robusta*) is simply too large a tree for planting in a narrow parkway. A more systematic approach to tree selection could have prevented or greatly reduced the resulting hardscape damage.

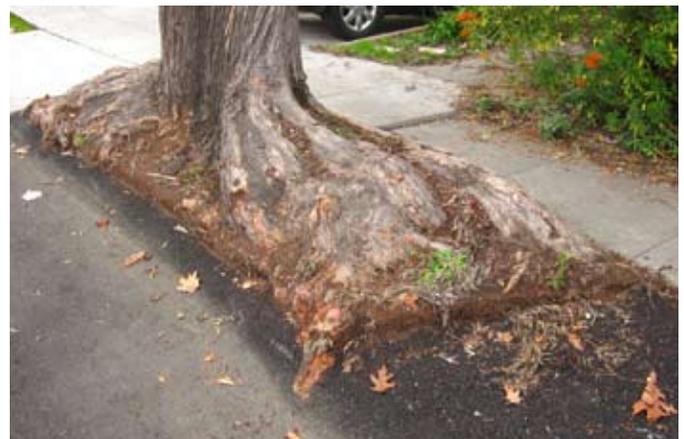
Replacing the curb and gutter would have caused excess root damage to this valuable tree. It was decided to hand compact asphalt around the root ball and thereby minimize damage. Water flow lines were restored and ponding eliminated to reduce mosquitos and threat of West Nile Virus. Asphalt was also used to patch the differential in the sidewalk. This treatment was less expensive than replacing the sidewalk but also temporary, as the asphalt is expected to break apart in time as the sidewalk continues to lift. Another option would have been to shift the sidewalk several feet away from the tree to minimize root damage.

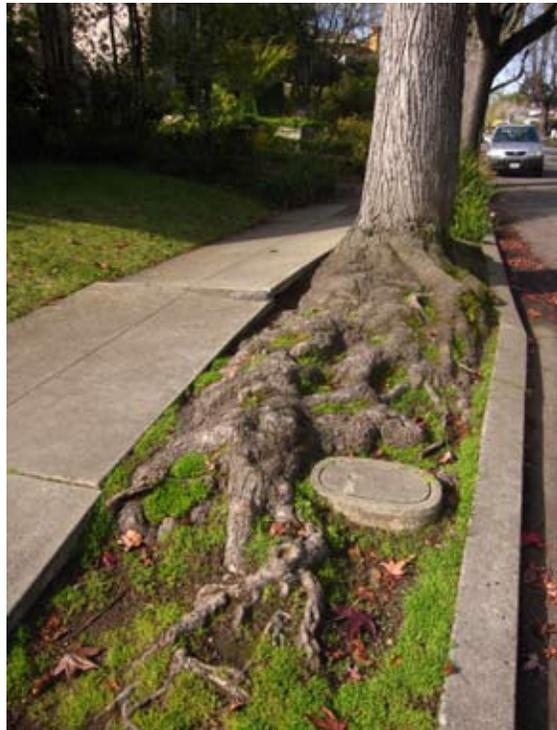
Costello and Jones (2003) in a test survey of trees in the San Francisco bay area, found that the average diameter of sweetgums (*Liquidambar styraciflua*), measured at ground level (DGL), was 55.6 inches. The average diameter of the trunk above the flare or root buttress (DAFB) was 21 inches. The ratio of the DGL to the DAFB was then calculated to be 2.64. This ratio is high when compared to other species. For example, red ironbark (*Eucalyptus sideroxylon*) is 1.26. Its root flare is much less pronounced. The liquidambar pictured here is not yet mature, but has already caused significant hardscape damage because the species’ trunk flare was not considered.

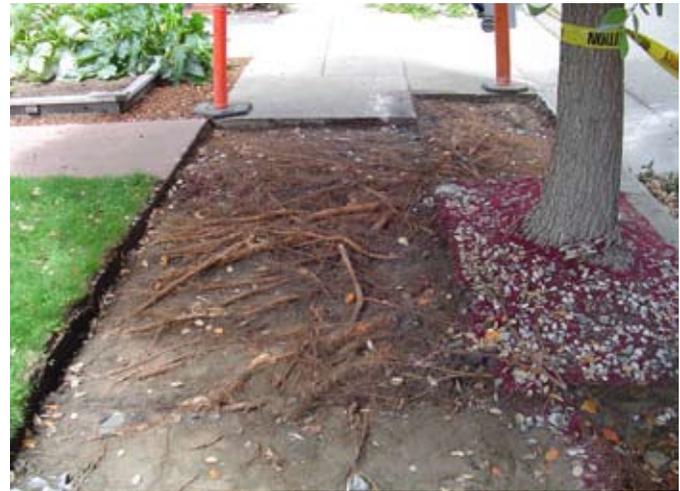
The roots of this New Zealand Christmas tree (*Metrosideros excelsa*) caused the adjacent pavement to buckle. Soil under the sidewalk was highly compacted and the lawn nearby heavily irrigated. The roots developed deeper in the turf area because the soil there was sandy, and only moderately compacted.

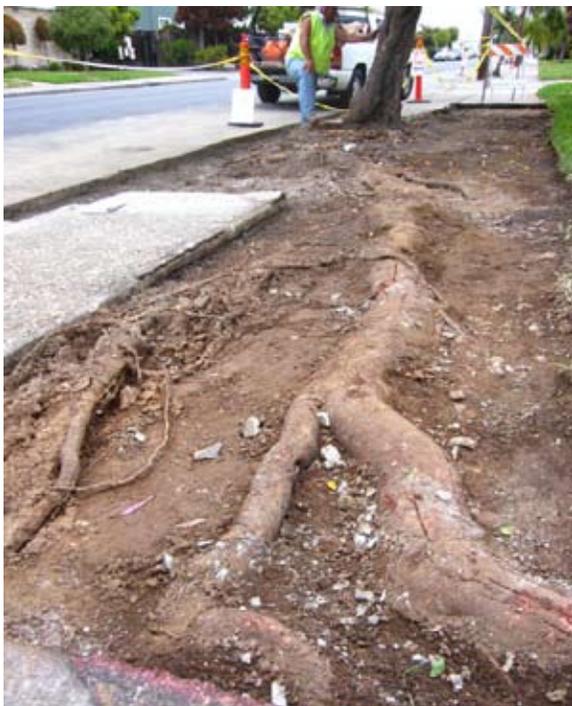
As typically required by municipal building codes, the soil below this sidewalk was compacted to over 85 percent bulk density. Irrigation of the adjacent lawn was so excessive, these large carob (*Ceratonia siliqua*) roots were precluded from growing toward the lawn. The tree was recommended for removal and replacement because it was unhealthy and an undesirable species. Furthermore, returning the sidewalk to grade would have caused severe root injury. A number of site modifications were specified to improve root zone conditions for the replacement tree. Educating homeowners and landscape professionals about proper water management is necessary to avoid similar mistakes.
